NASA/CR—1999-209164/VOL2

# Stirling Space Engine Program

## Volume 2—Appendixes A, B, C, and D

Manmohan Dhar  
Mechanical Technology Inc., Latham, New York

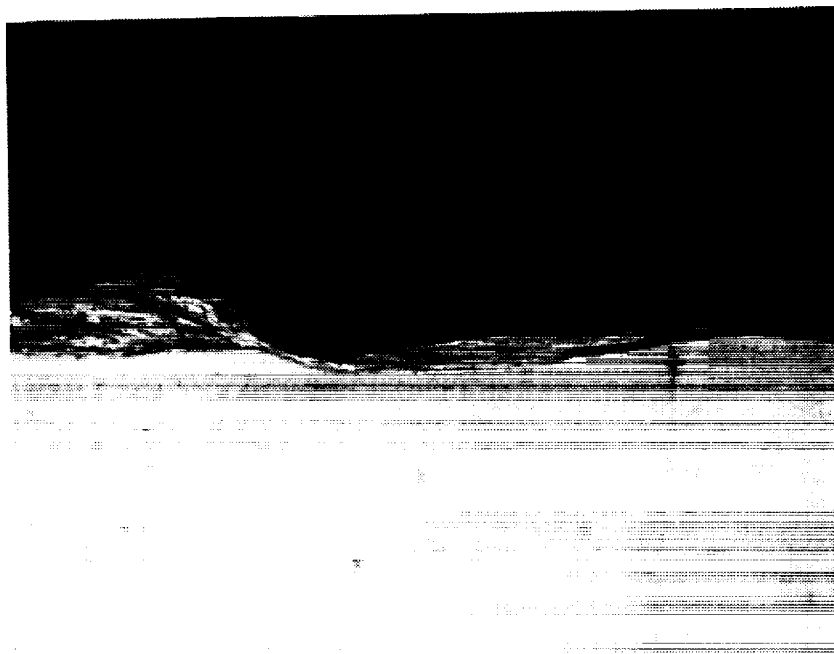
L567-3 400X  
FIGURE 2 - RECAST LAYER IN IN718 EDM HOLE.  
(LONGITUDINAL SECTION, ETCHED).

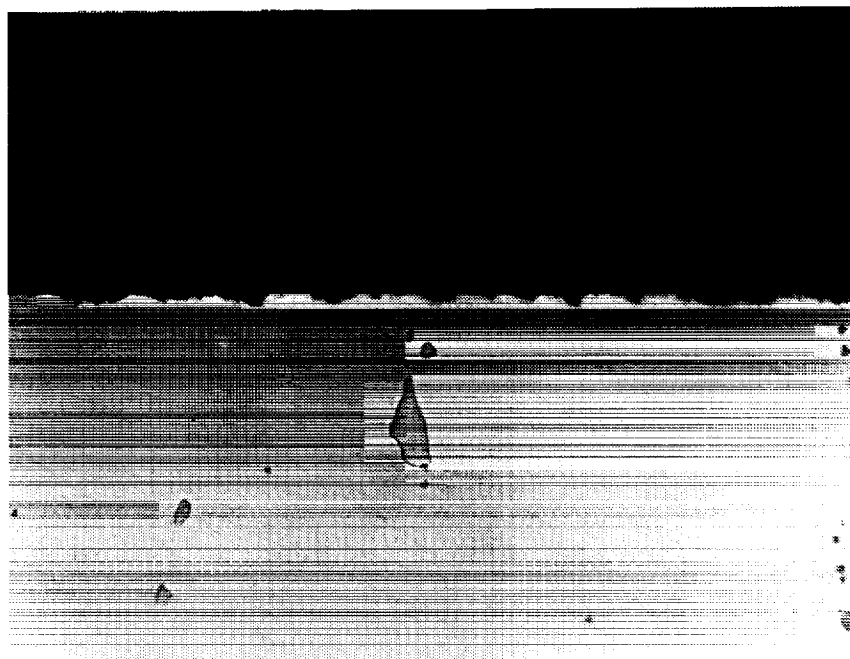
L652-4 400X  
FIGURE 3 - CHEMICALLY MILLED SURFACE ON POLISHED  
IN718, SOLUTION #2

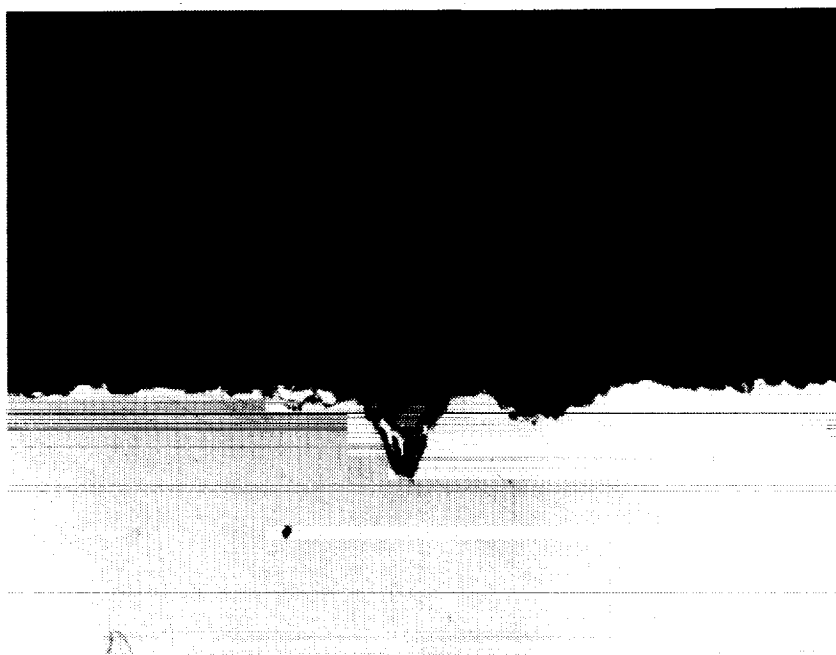
L652-5 400X  
FIGURE 5 - LARGEST PIT OBSERVED ON THE POLISHED IN178  
AFTER CHEMICAL MILLING IN SOLUTION #2.  
(PIT DEPTH IS APPROXIMATELY 0.001 INCH)

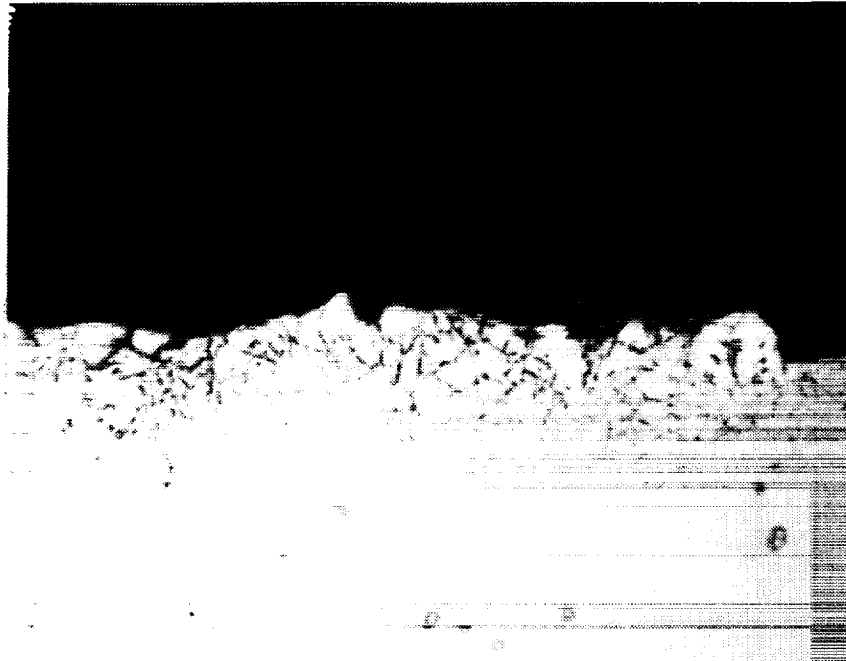
L642-2

FIGURE 1 - SURFACE MICROCRACKS OBSERVED ON AN EDM  
AND CHEMICALLY MILLED SURFACE.

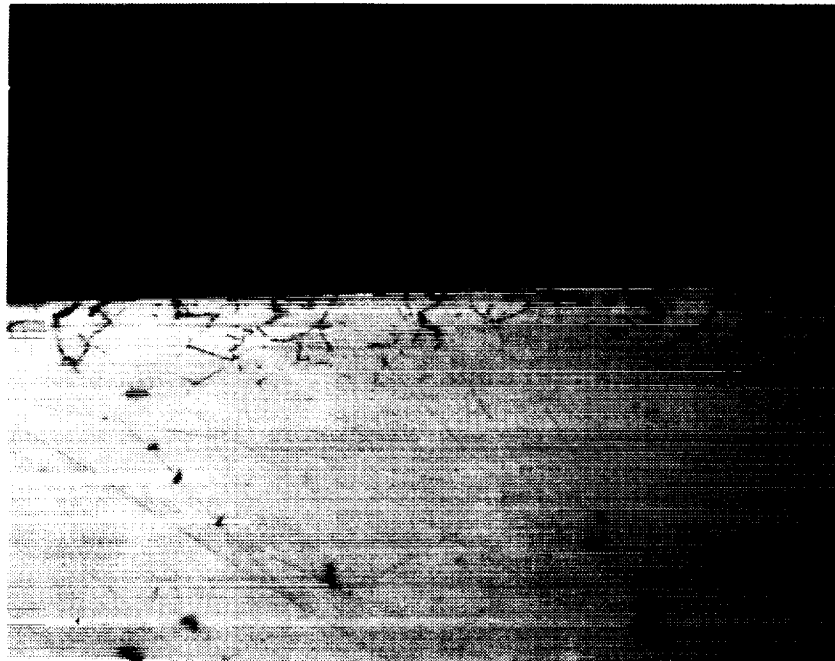
L642-5

FIGURE 2 - SURFACE MICROCRACKS OBSERVED ON A  
CONVENTIONALLY MILLED AND CHEMICALLY  
MILLED SURFACE.

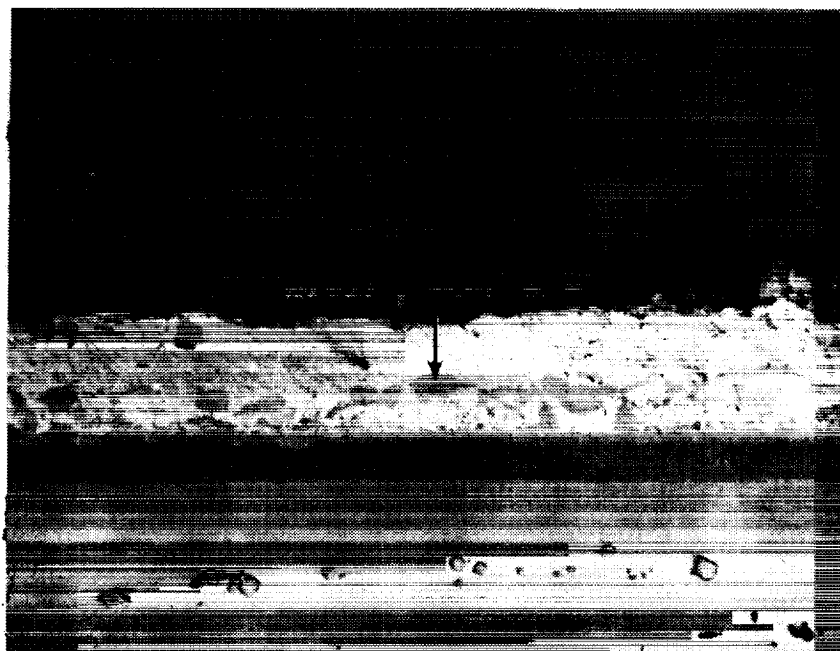
L640-1 400X  
FIGURE 1 - BERYLLIUM (TOP) TO IN718 (BOTTOM) BRAZE  
JOINT SHOWING COPPER RICH REGIONS (ARROW)

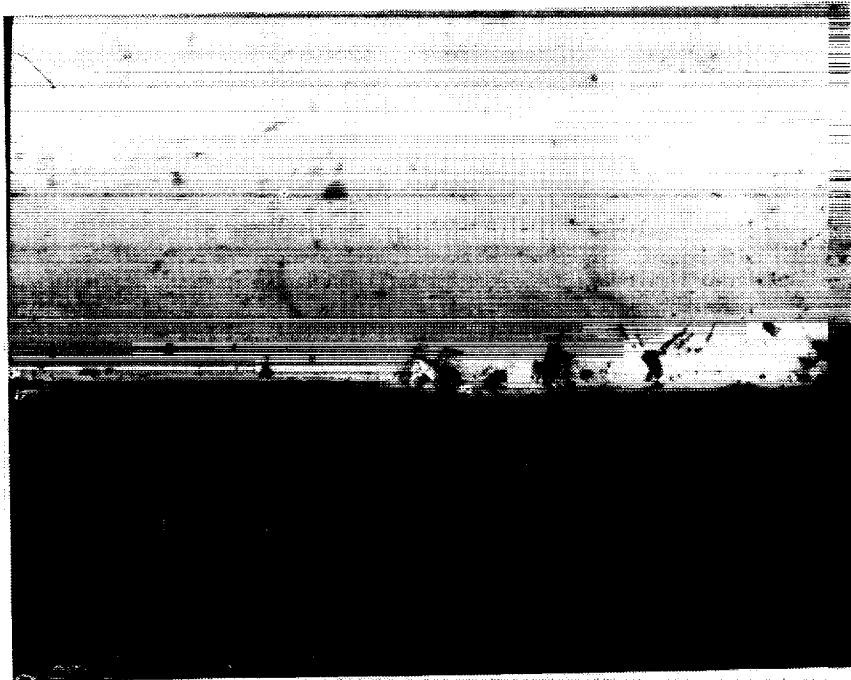
L640-11

FIGURE 3 - BERYLLIUM (TOP) AND IN718 (BOTTOM) BRAZE JOINT AFTER SHEAR TEST SHOWING FAILURE AT THE BERYLLIUM TO BRAZE METAL INTERFACE.

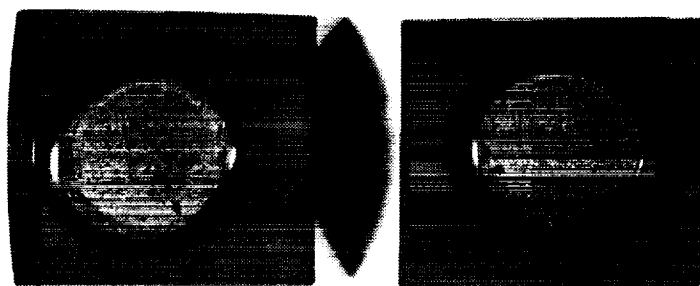
L632-26 X1.6  
FIGURE 3 - ALUMINUM OXIDE COATING BOND STRENGTH SAMPLE  
AFTER TEST SHOWING EPOXY BOND FAILURE

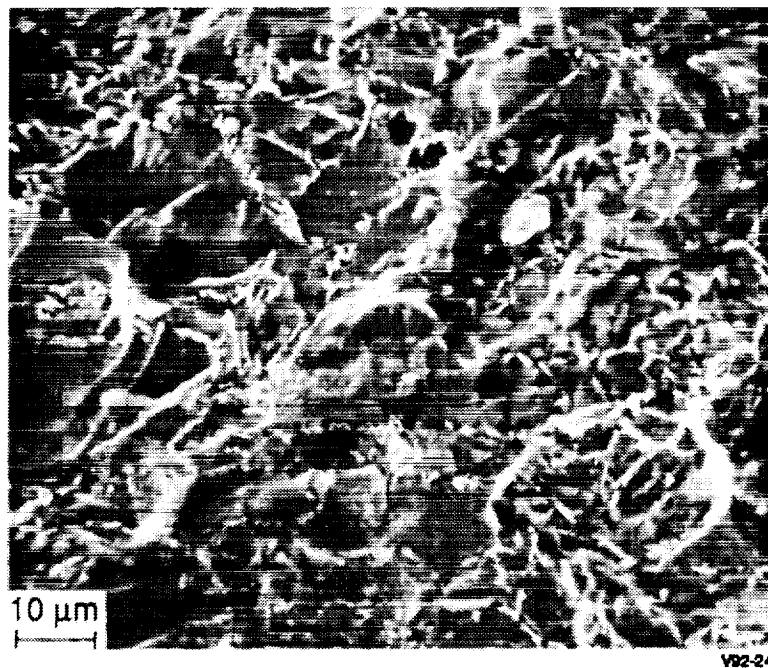
Figure 3. Scanning Electron Micrograph of an Inconel 718 Surface After Chemical Milling

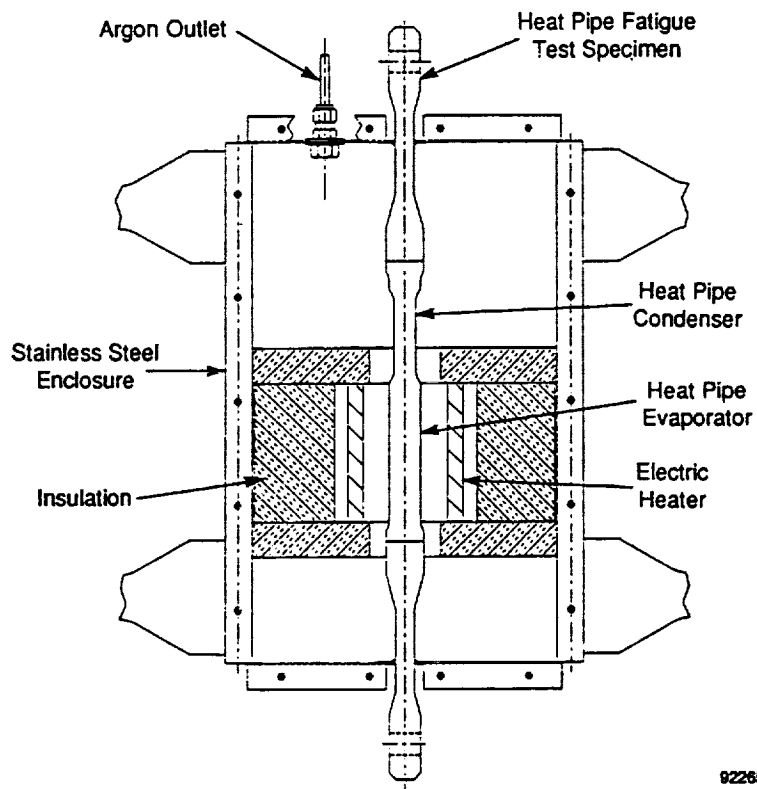
Figure 4. Heat Pipe Fatigue Test Setup

The HPFTS was subjected to 36 test sequences under thermal and mechanical load for a total test time of 1090 hr. Maximum temperatures in the condenser were 1000 K (1340°F) or 1050 K (1430°F), depending on the test sequence being conducted. Total hours at specific condenser temperatures were: 775 hr at 950 K (1250°F), 275 hr at 1000 K (1340°F), and 40 hr at 1050 K (1430°F). These operating times and temperatures were shown to produce approximately 2% creep in independent creep tests. Creep strain was not recorded during heat pipe testing. Temperature was monitored with type K thermocouples at ten locations along the length of the heat pipe. A plot (Figure 5) of the

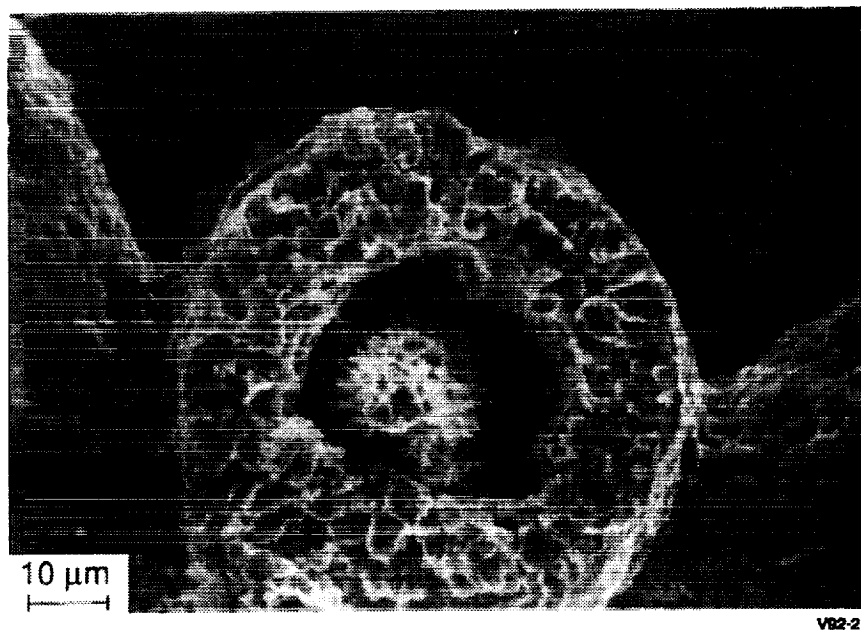
Figure 9. Scanning Electron Micrograph of Fractured Wire in Deposit Region Showing Cored Structure

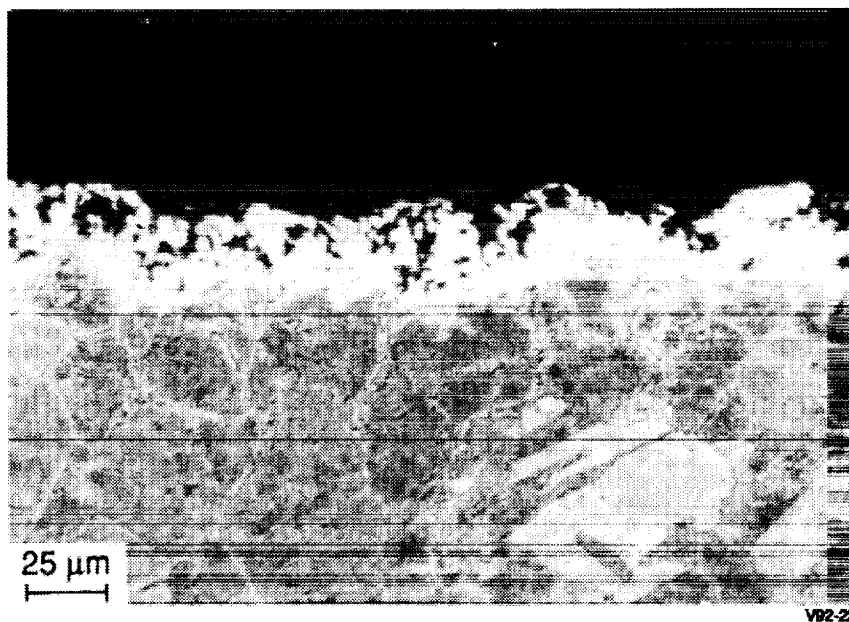
Figure 21. Optical Micrograph of Oxygen-Accelerated Corrosion

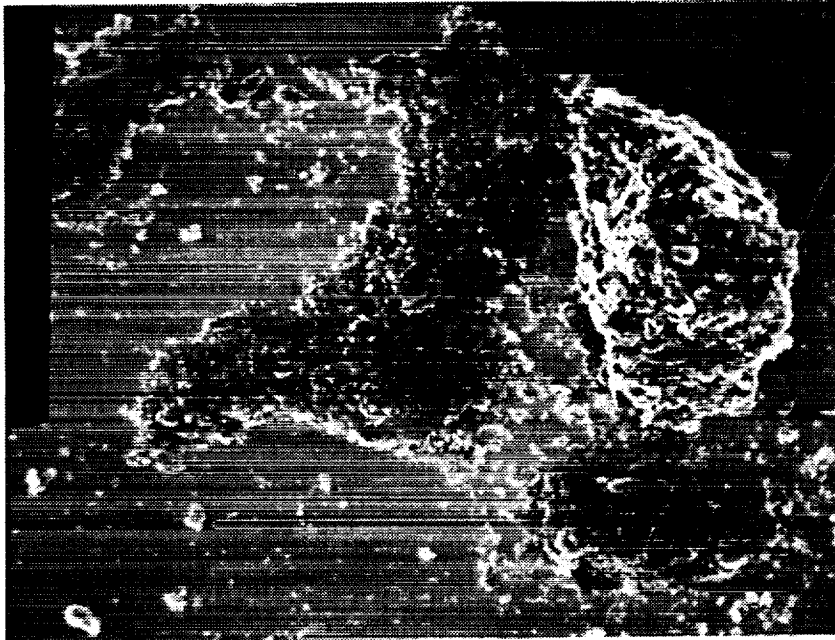
S595-14 X300  
FIGURE 1 - WEAR DEBRIS GENERATED DURING CARBON BLOCK  
Ni PLATED DISC TEST. NOTE LARGE CONGLOMERATE  
PARTICLES. (SEM PHOTOGRAPH).

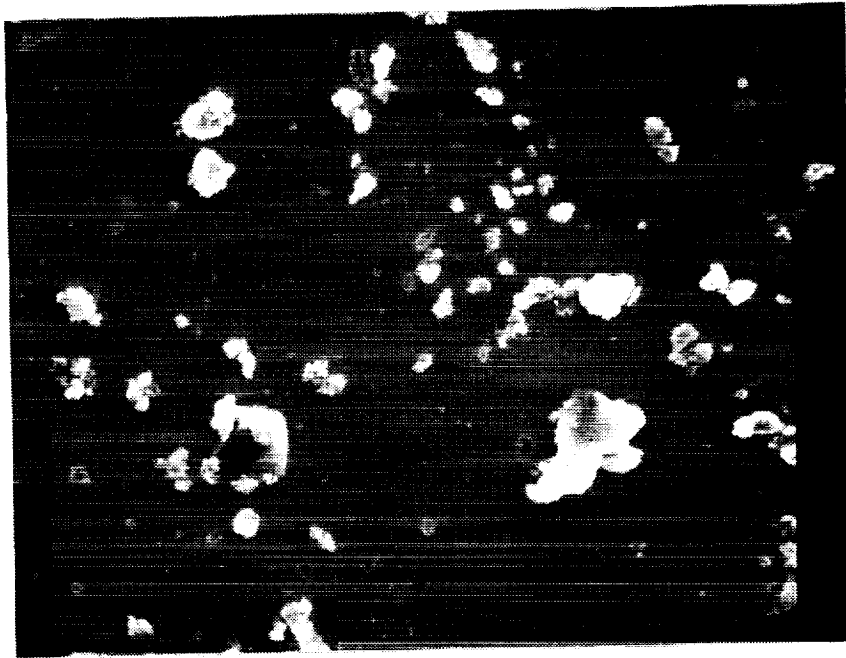
S595-13 X1000  
FIGURE 3 - VERY FINE INDIVIDUAL WEAR PARTICLES.  
(SEM PHOTOGRAPH).

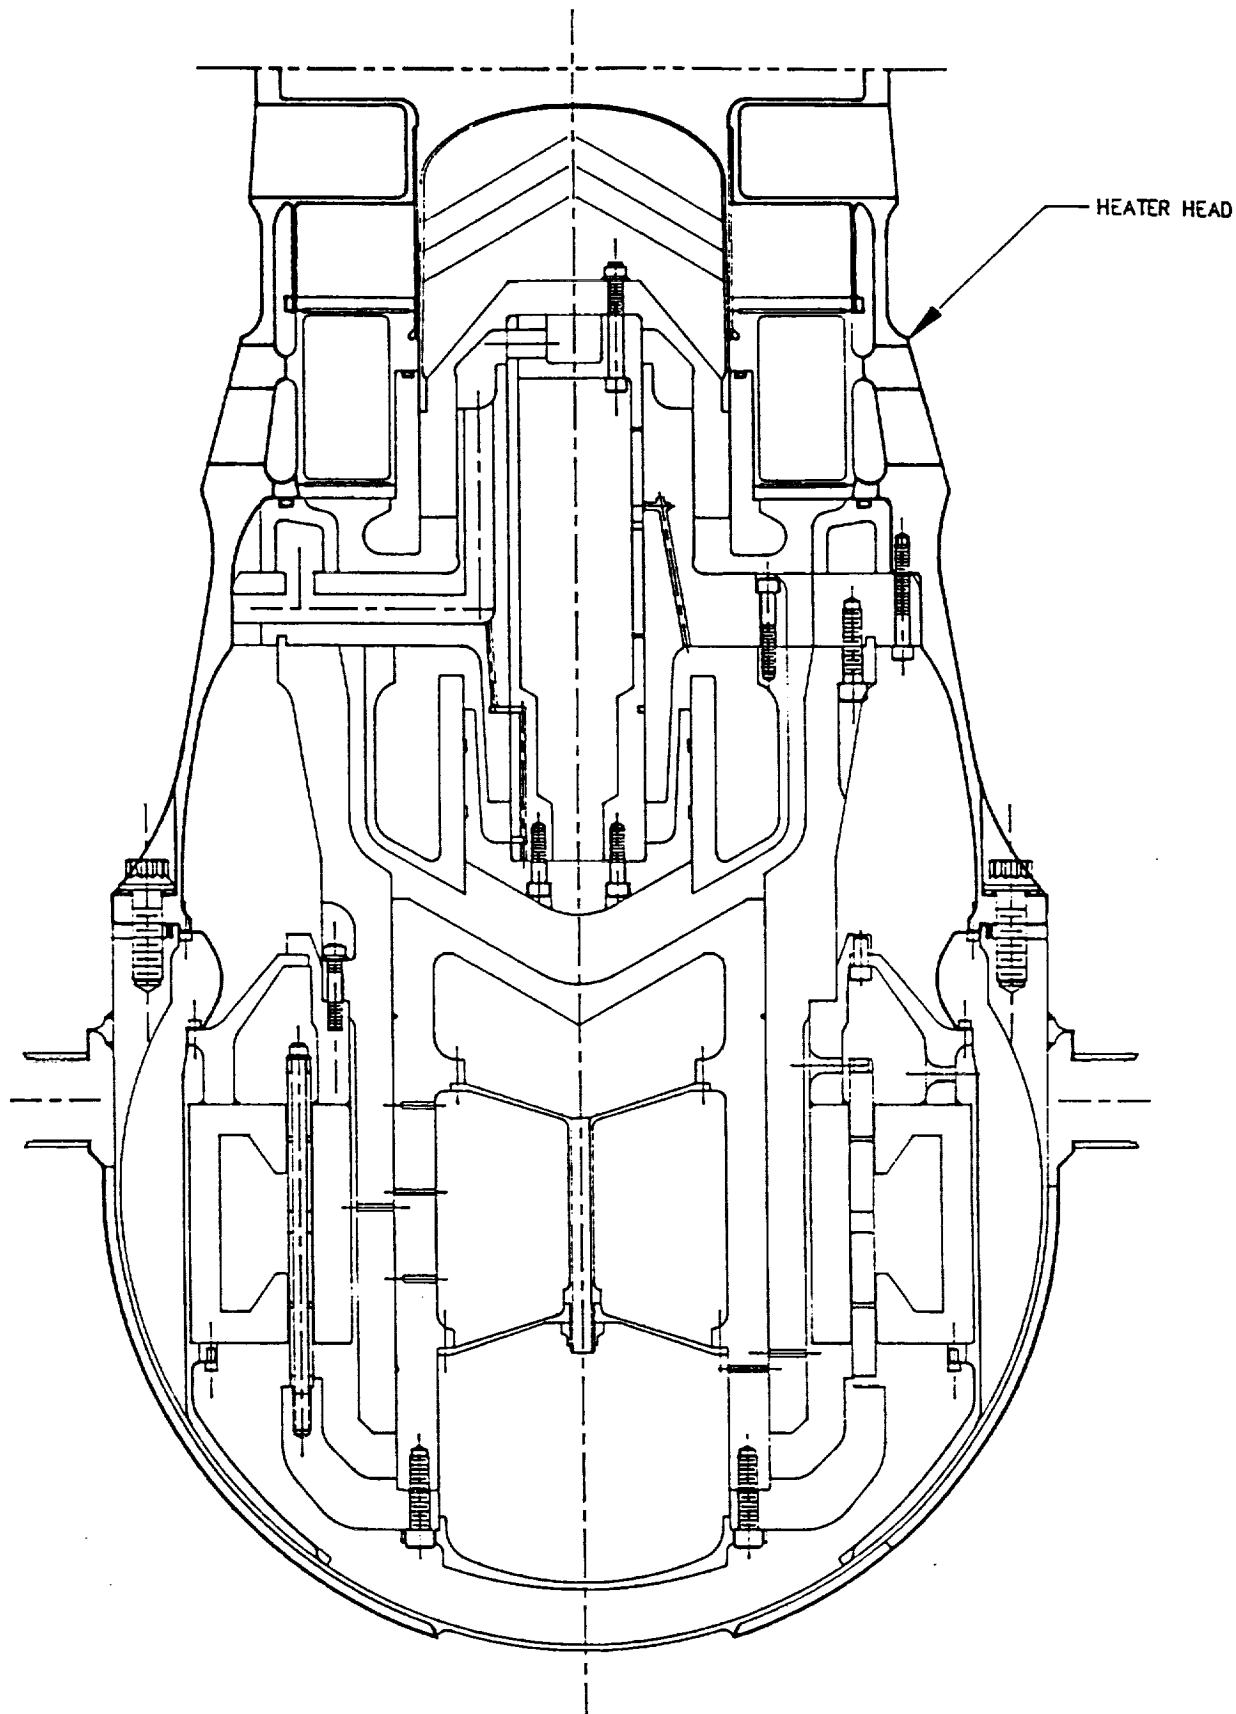
FIGURE 1: SSE FREE-PISTON ENGINE

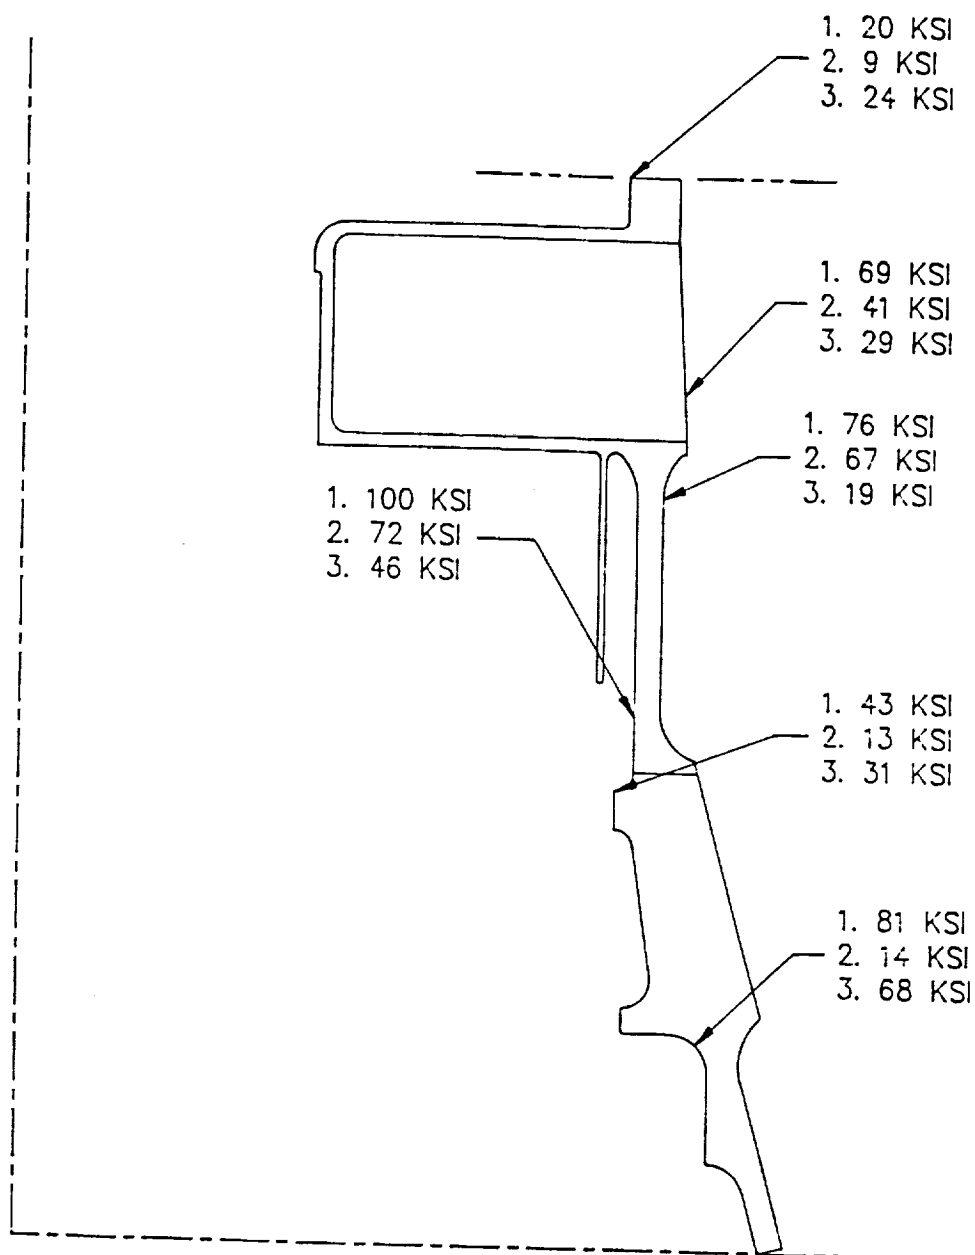
FIGURE 2: SSE HEATER HEAD, TYPICAL STRESS LEVELS (von Mises)

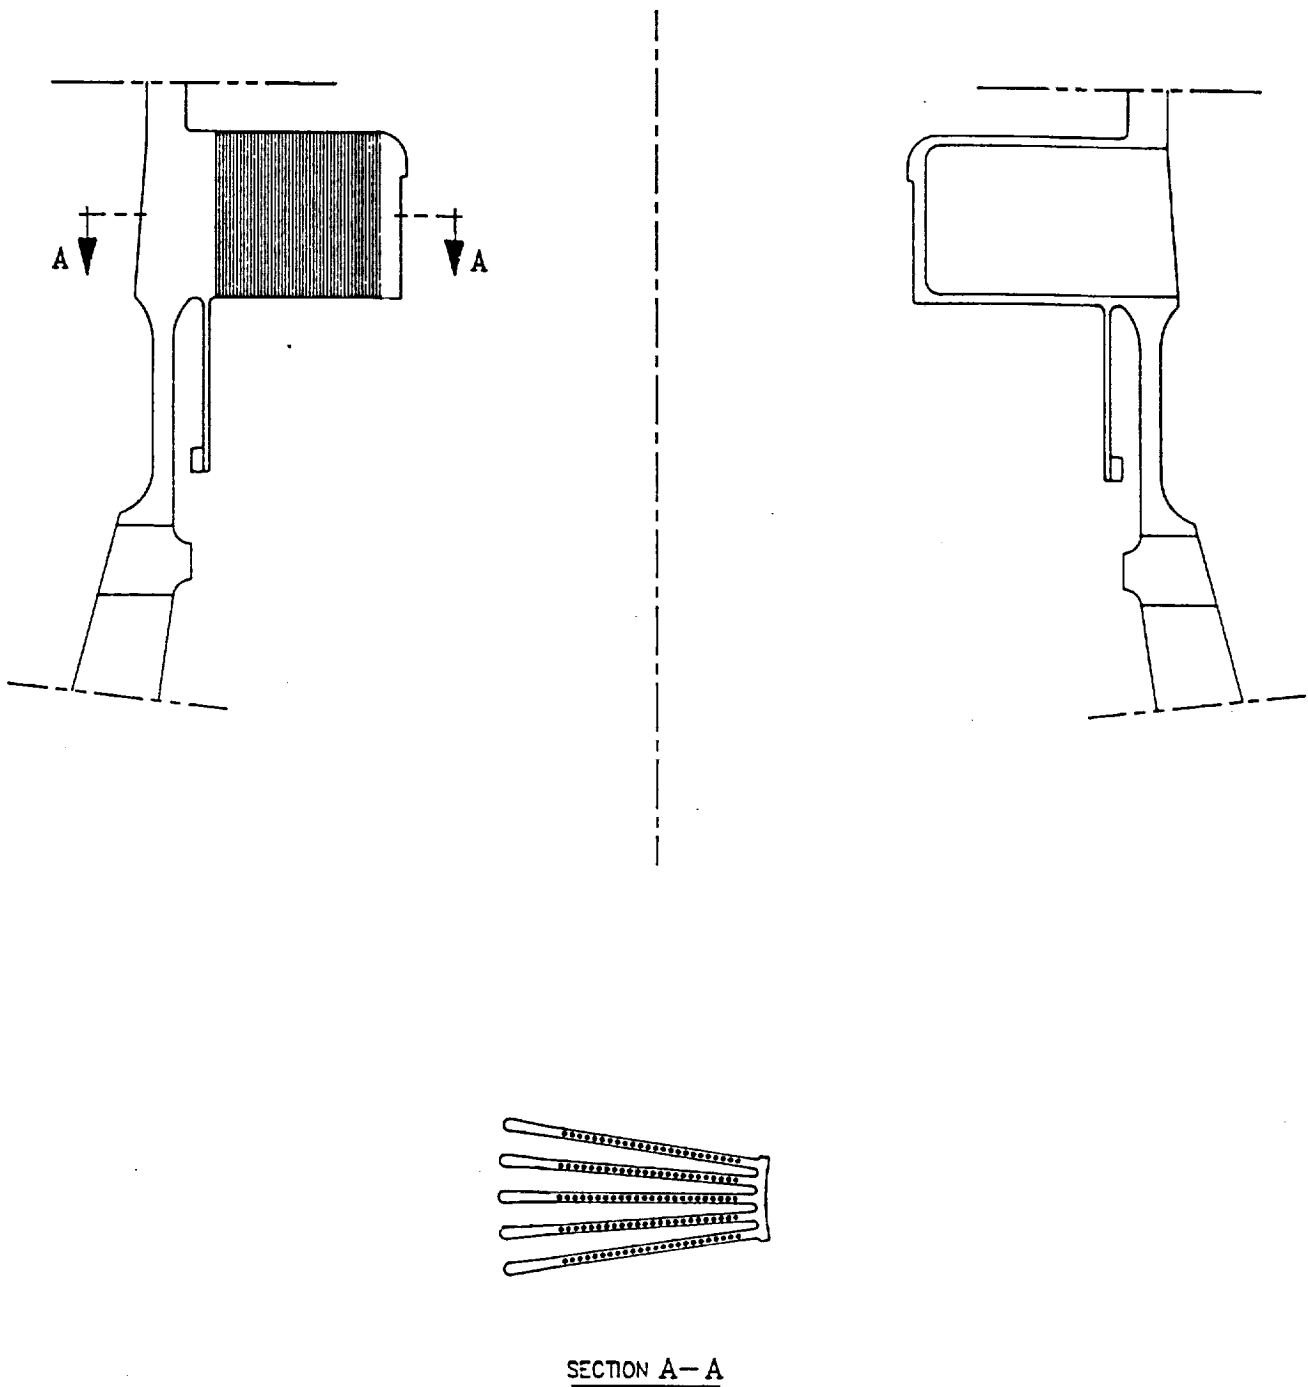
FIGURE 3: STARFISH HEATER HEAD CONFIGURATION

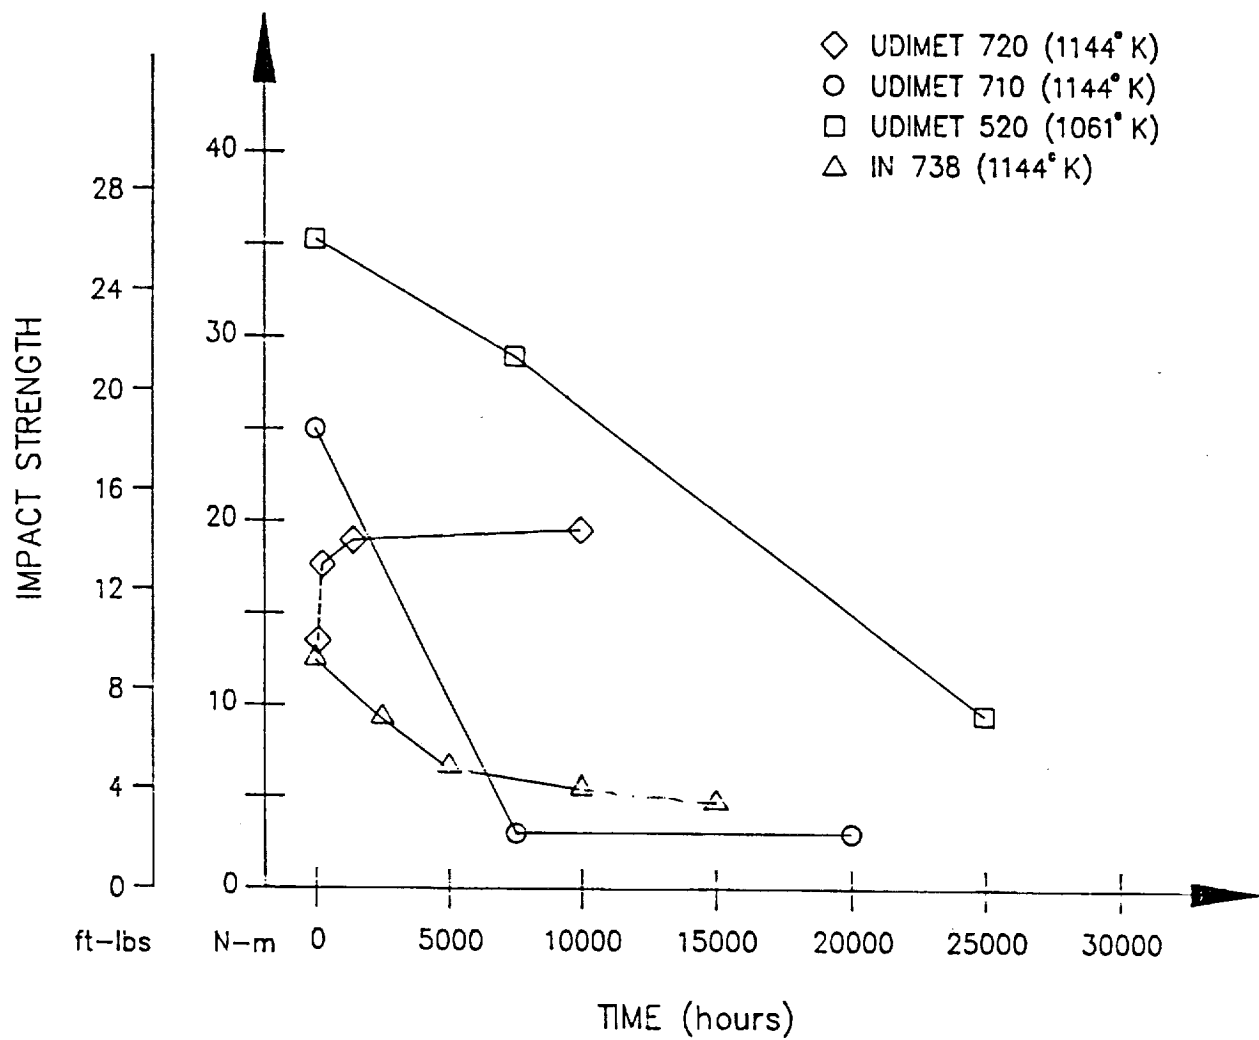
FIGURE 4: 1174° K Impact strength vs. time for several alloys exposed to elevated temperatures (in parentheses).

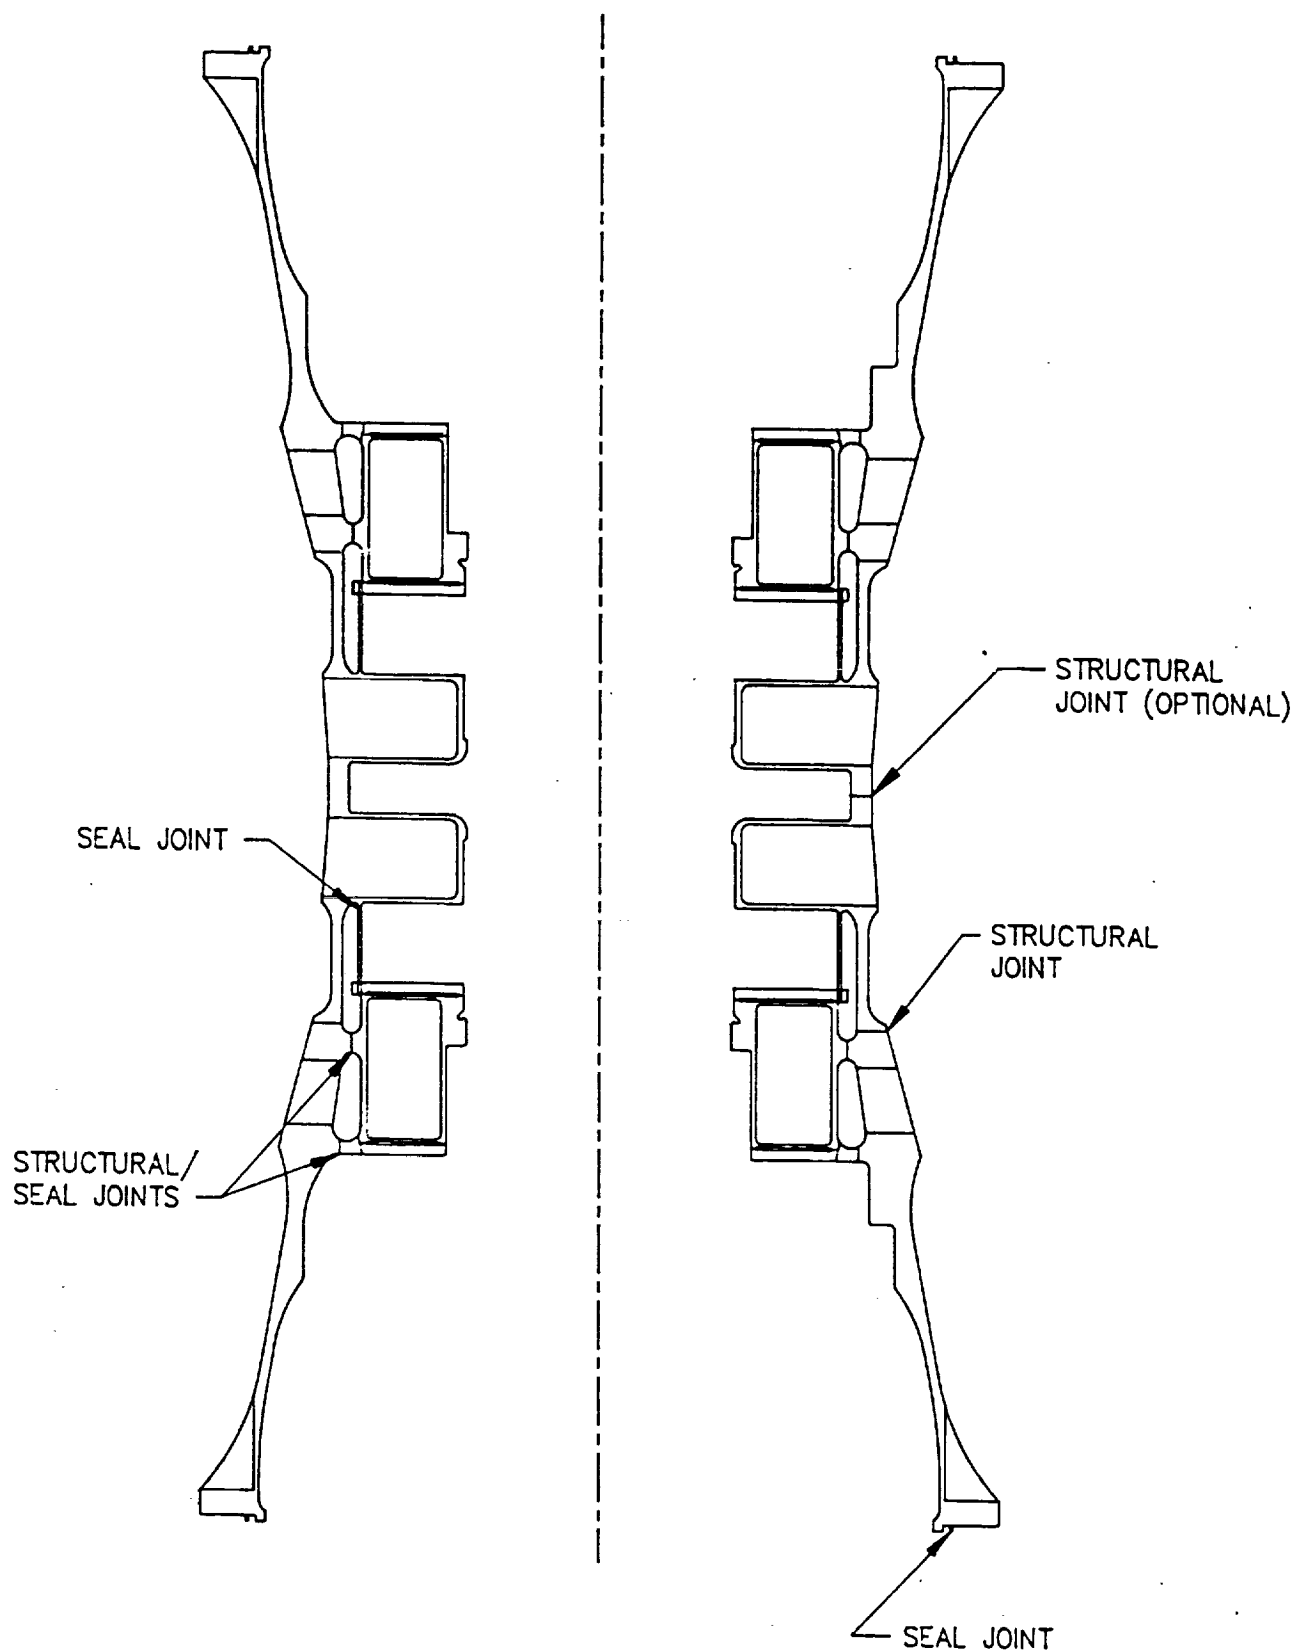
FIGURE 5: POSSIBLE JOINT LOCATIONS IN SSE HEATER HEAD
